**Actions of the Road and Bridge Research Institute
in assessing the technical condition of public
roads and road engineering structures in areas
affected by the state of natural disaster**

SUMMARY REPORT

Warsaw, December 2024

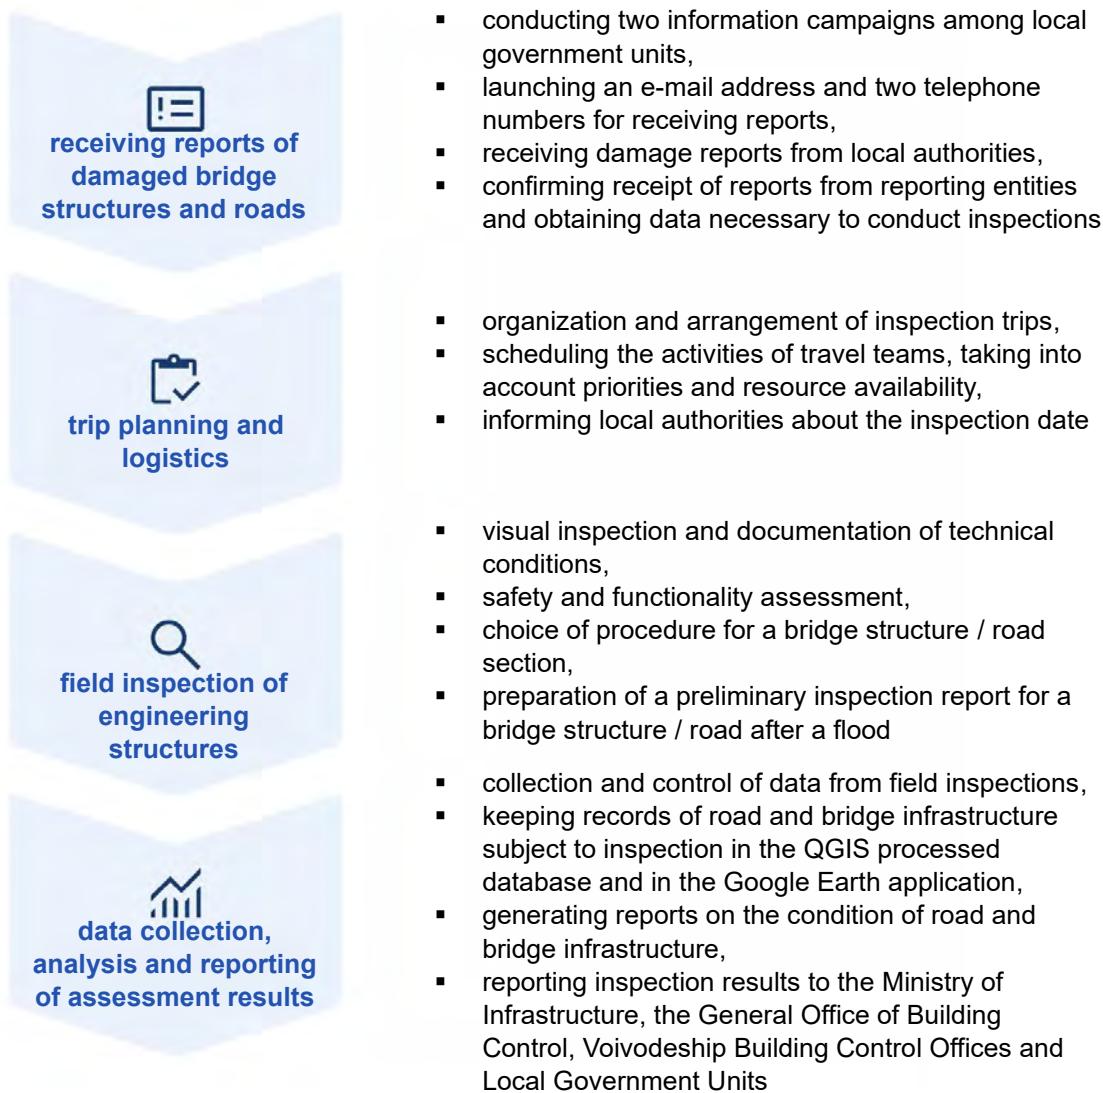
Figure 1. The process of assessing the technical condition of bridge structures and roads

Figure 1 illustrates the main flowchart of activities related to the assessment of buildings whose technical condition was verified during inspections. Operationally, the flowchart represents the sequence of physical and informational activities performed at each stage of the procedure, enabling the transition to the next phases of the process. The project began with two separate information campaigns: one concerning bridge inspections and the other concerning road inspections. The campaigns were targeted at local government units located in areas affected by the state of natural disaster.

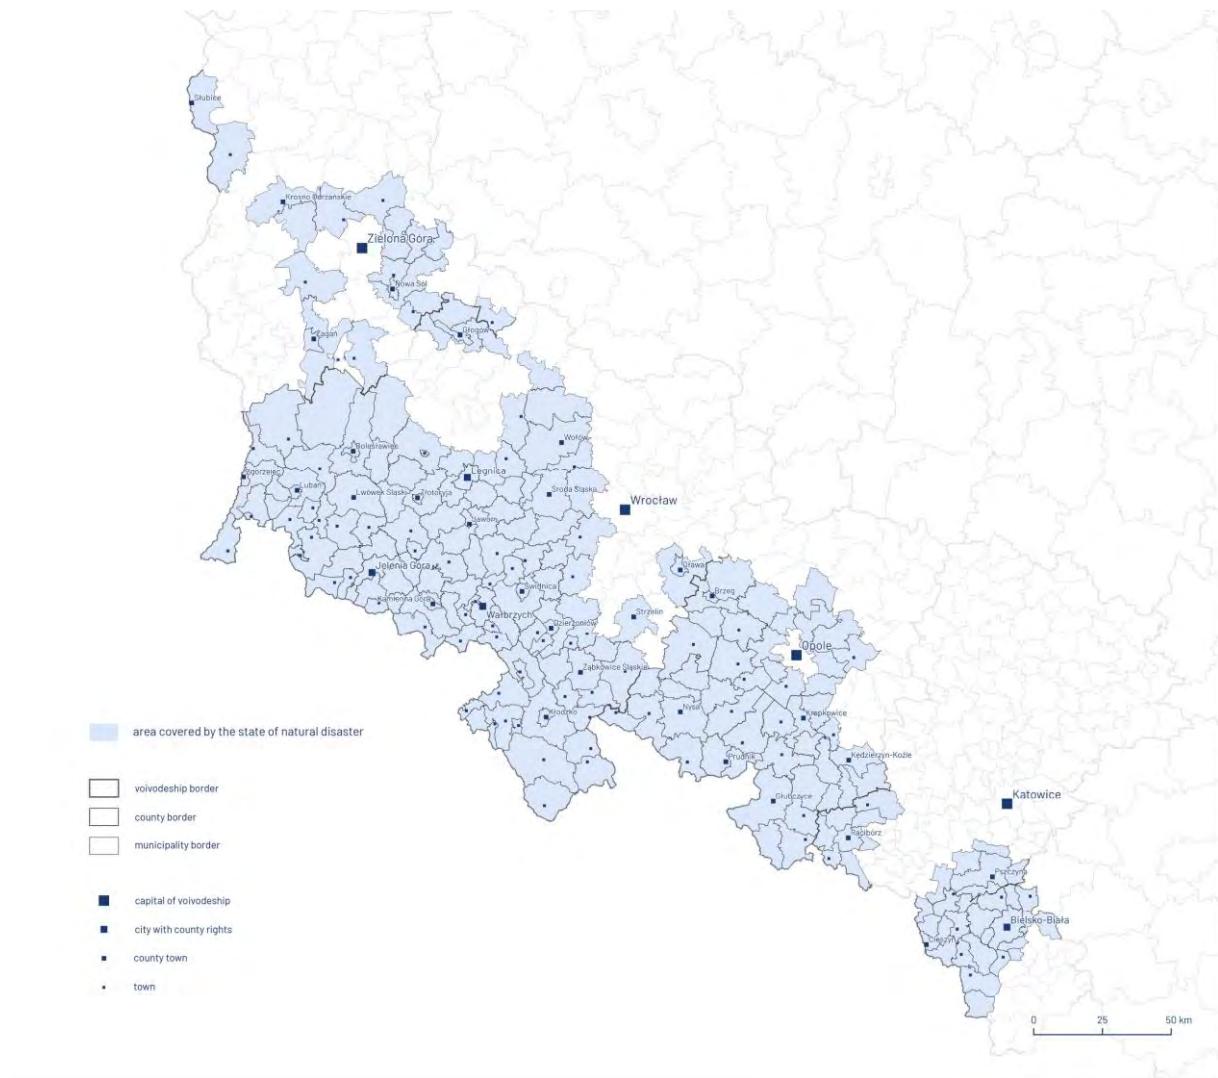
Figure 7. Administrative map of southwestern Poland with areas affected by a state of natural disaster

The areas affected by the state of natural disaster in southwestern Poland are shown on Figure 7.

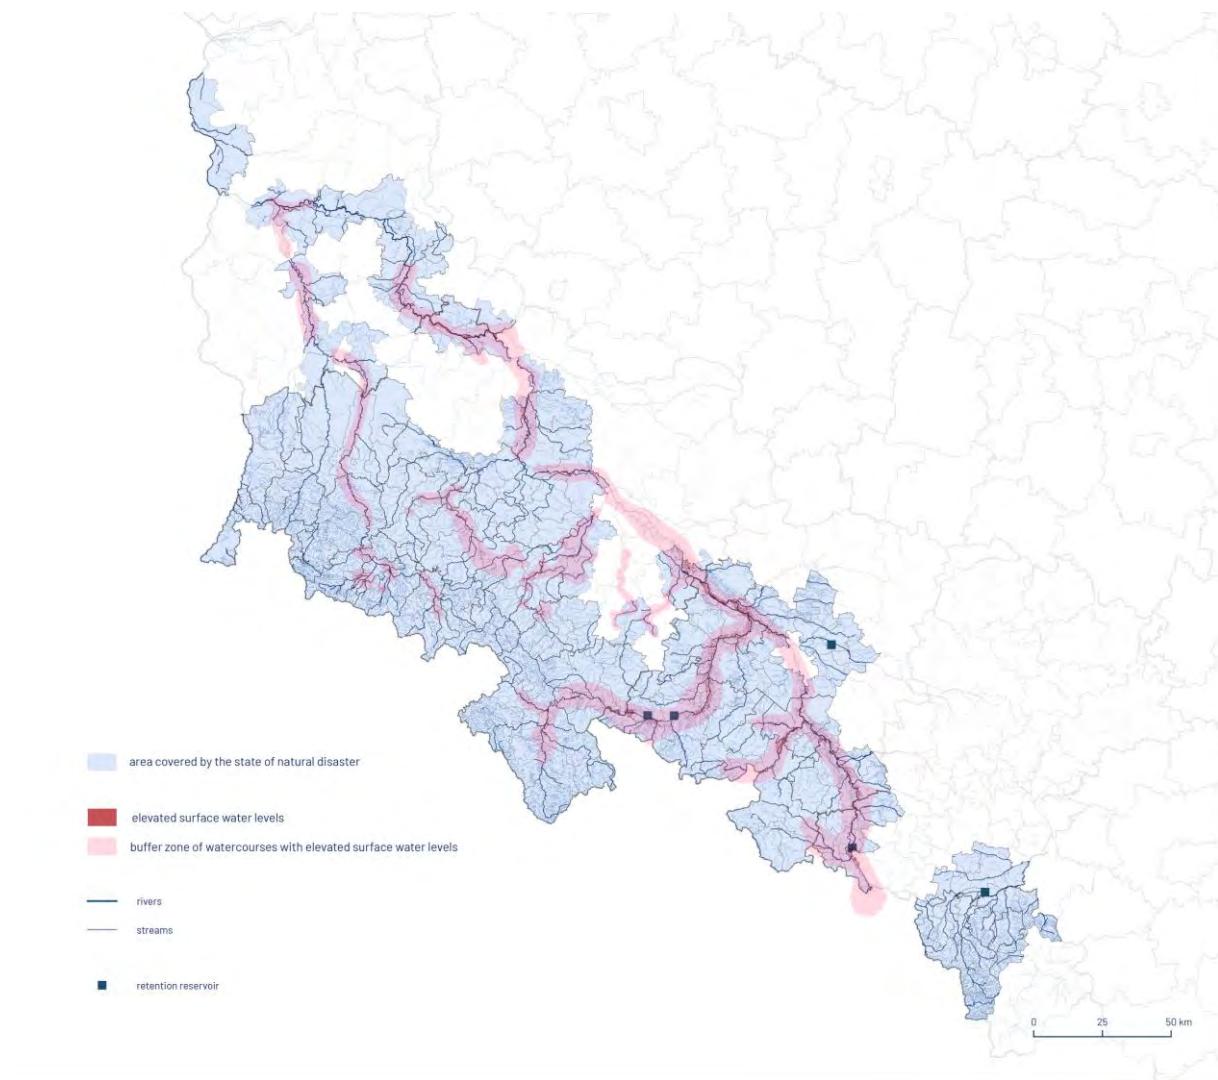
Figure 9. Map of hydrological conditions

The map above (Figure 9) shows the water network of the study area, as well as the elevated surface water levels resulting from this year's flood. Additionally, a buffer area has been designated on the map to identify areas most affected by flooding and structures vulnerable to flooding.

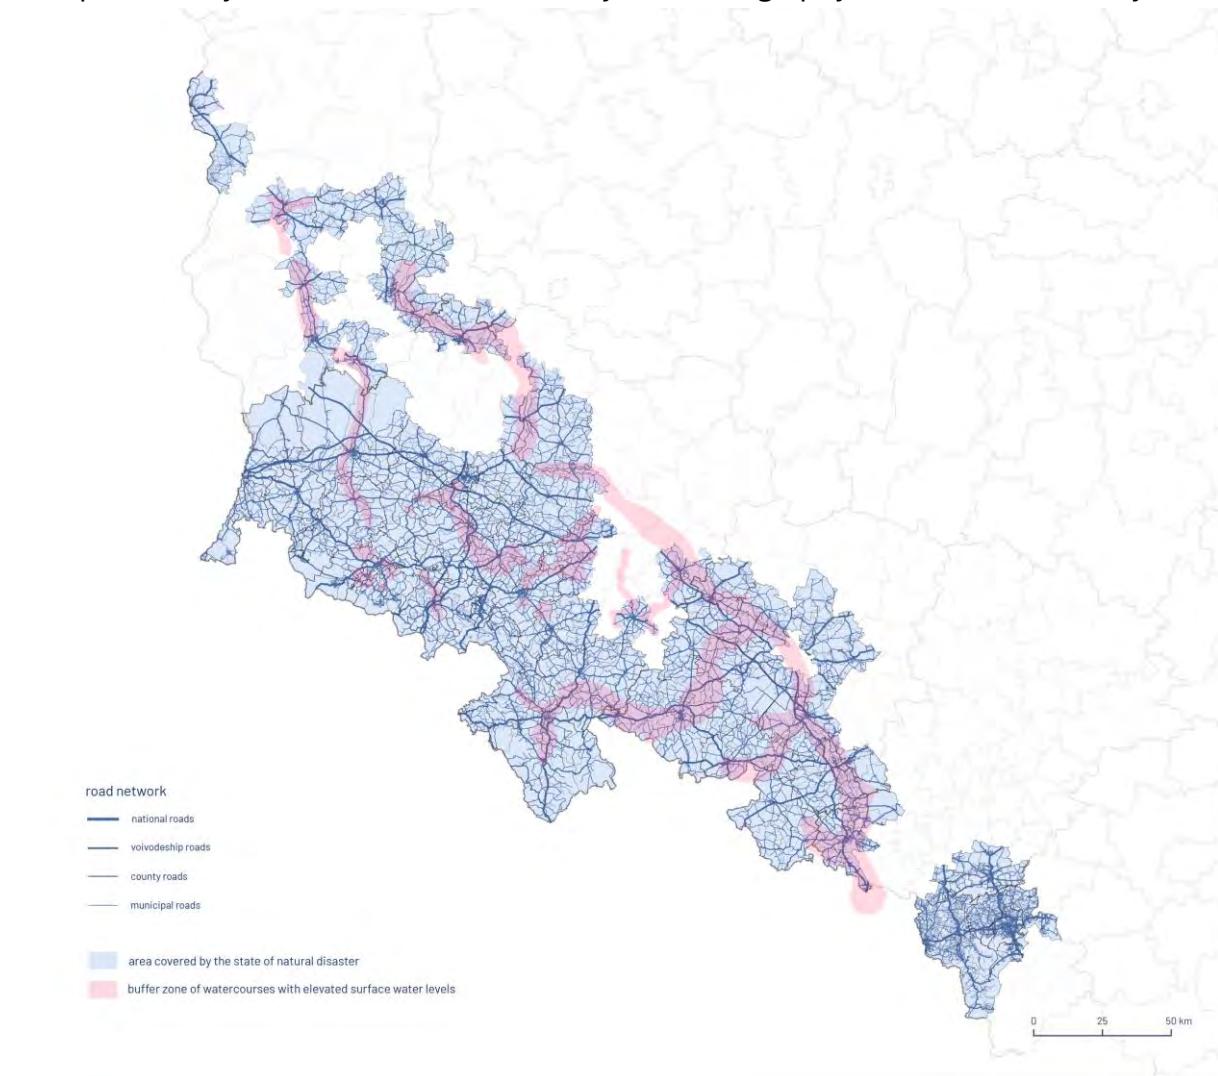
Figure 10. Road network map

Below is a detailed road network diagram (Figure 10) by road category, based on BDOT10k data provided by the Head Office of Geodesy and Cartography, focused on the study area.

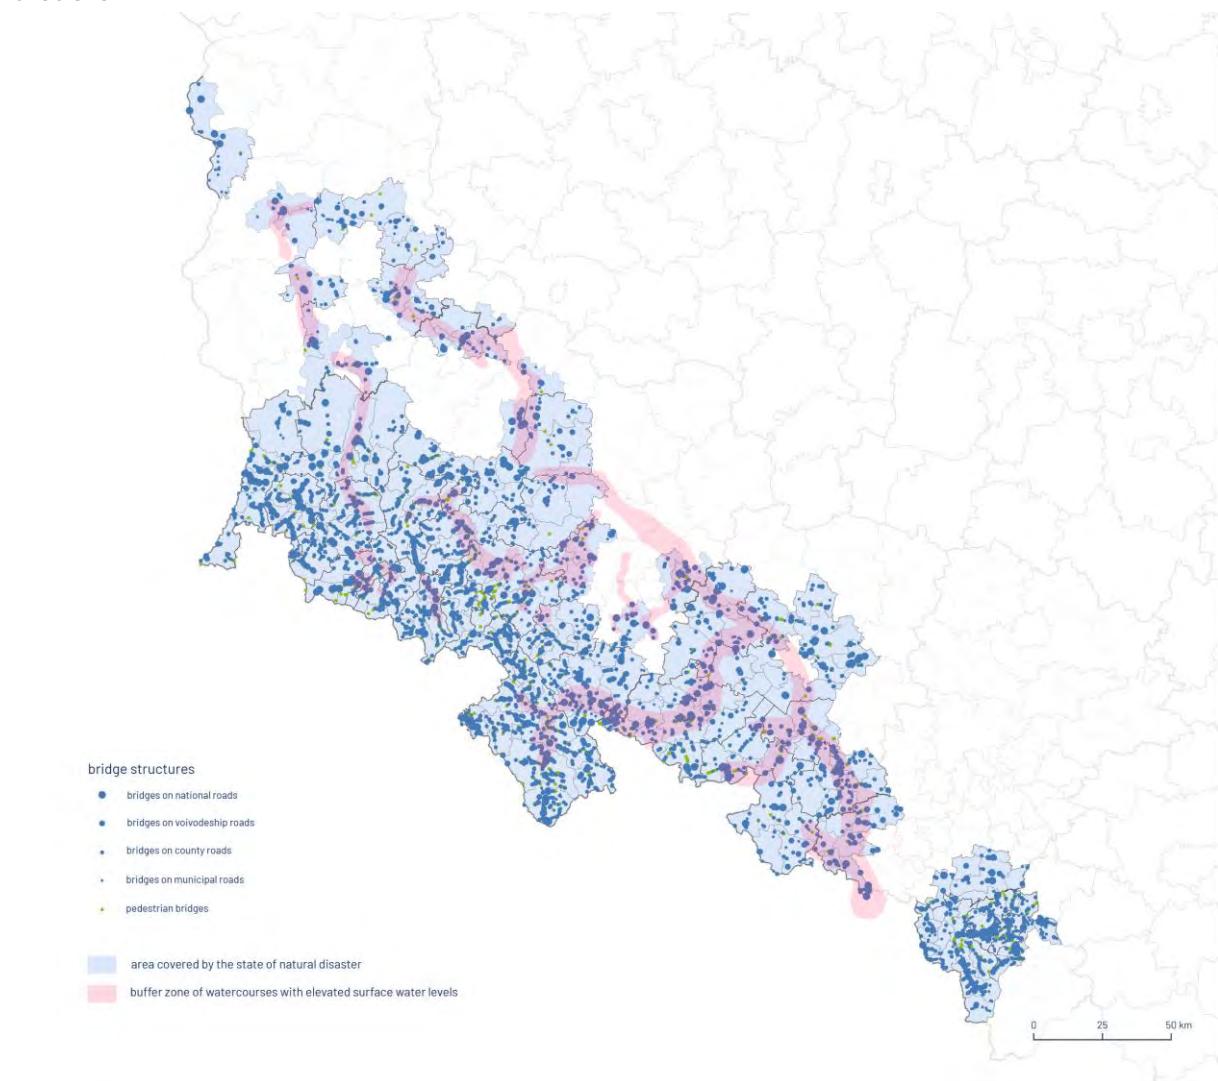
Figure 11. Map of bridge structures

Due to the large number of rivers, streams, and creeks, the flood-affected area is characterized by a very large number of bridge structures. Using the BDOT10k database, bridges located along national, voivodeship, county, and municipal roads, as well as footbridges, were identified. Figure 11 shows these structures in the area of the natural disaster.

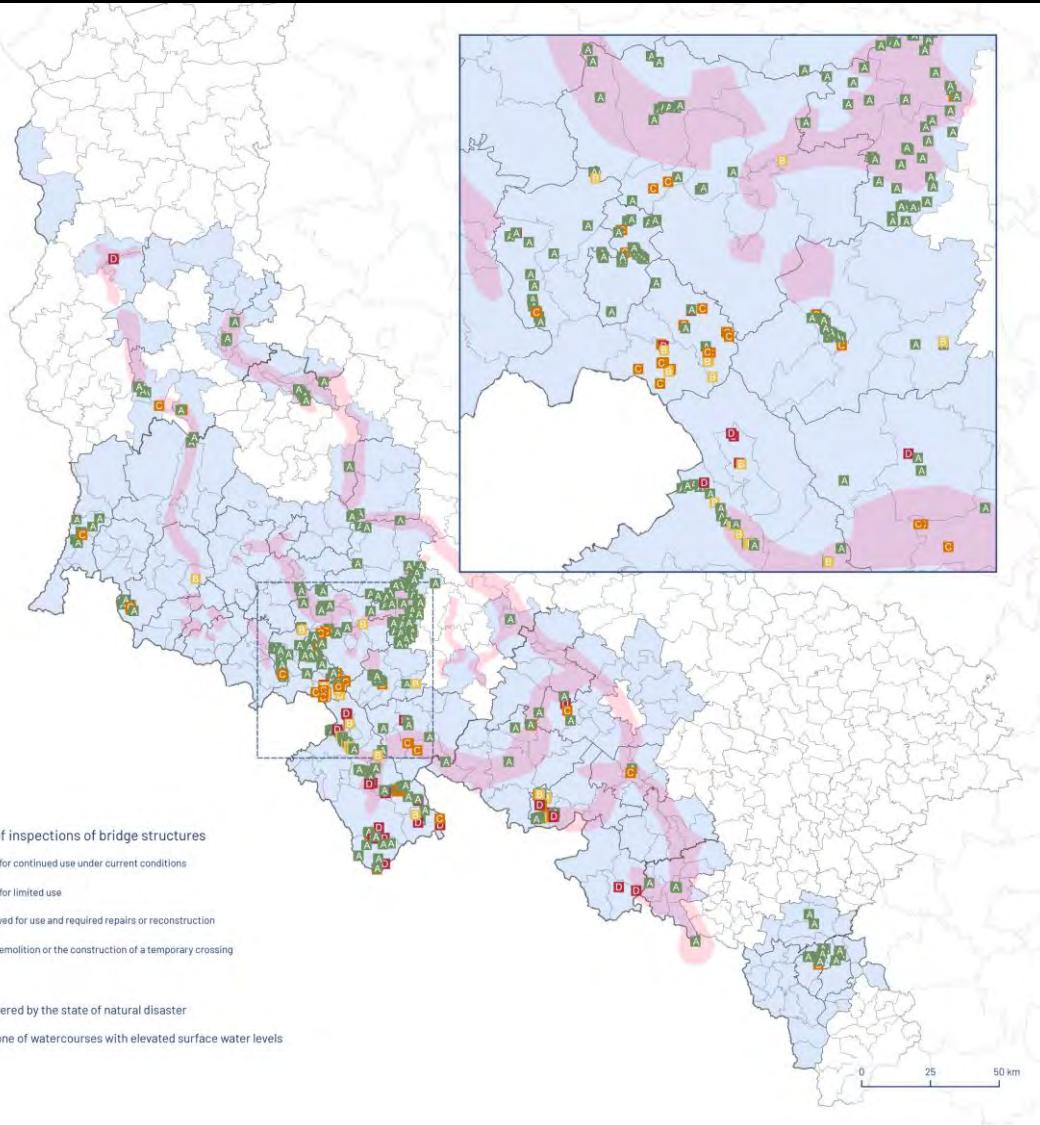
Figure 12. Spatial arrangement of bridge structures with assigned assessment categories

The spatial distribution of bridge structures along with the assigned assessment categories is presented in Figure 12. The data analysis shows that the largest number of structures assessed in categories C and D are located in the Lower Silesian Voivodeship, the area most affected by the effects of the September flood.

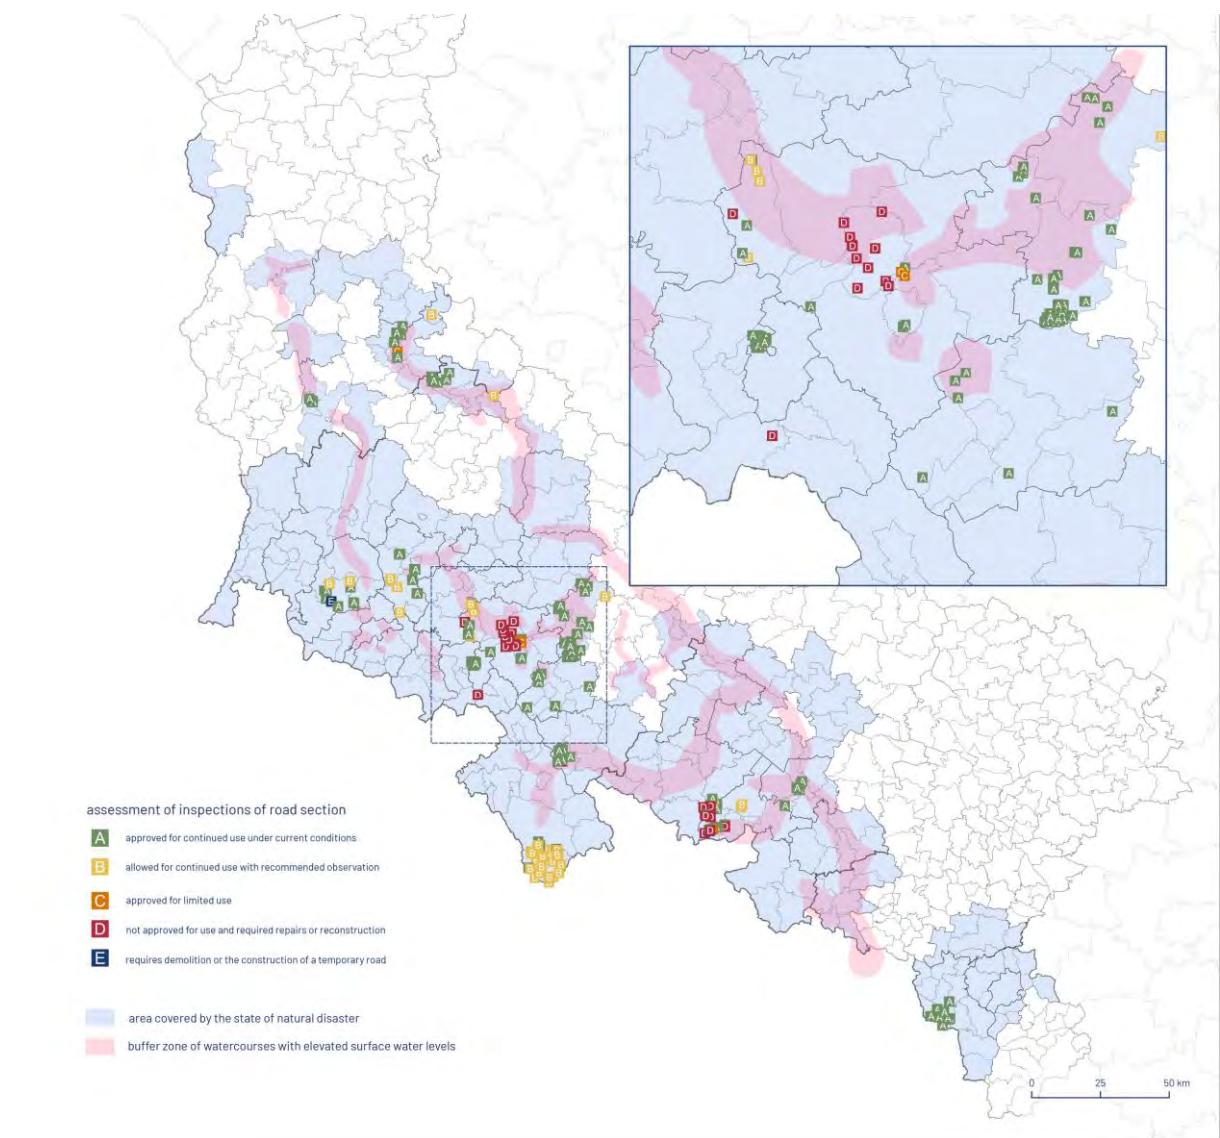
Figure 13. Spatial distribution of road sections with assigned assessment categories

The spatial distribution of road sections, along with the assigned rating categories, is presented in Figure 13. The analysis shows that the largest number of road sections in categories D and E are located in the Lower Silesian Voivodeship, the area most affected by the September flood.
